VERSION 7.2B
May 2025

Product release notes

Robotics Firmware

ROSS

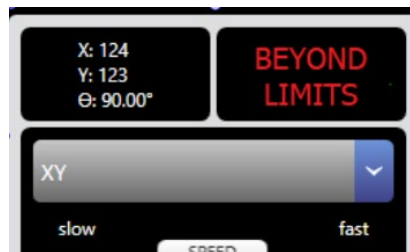
Various messaging in SmartShell and the Furio web interface warn operators if the pedestal is beyond limits. A pedestal could find itself beyond limits after loading a studio map, or returning from local control, in which case the primary indicator can be seen in SmartShell:

When beyond limits, the XY axis can only be operated by the joystick and movement is permitted only towards the closest edge of the operating zone, within a range of 90 degrees in either direction.
