# Product Release Notes

## Robotics Firmware

### VERSION 7.2e – FEBRUARY 2026

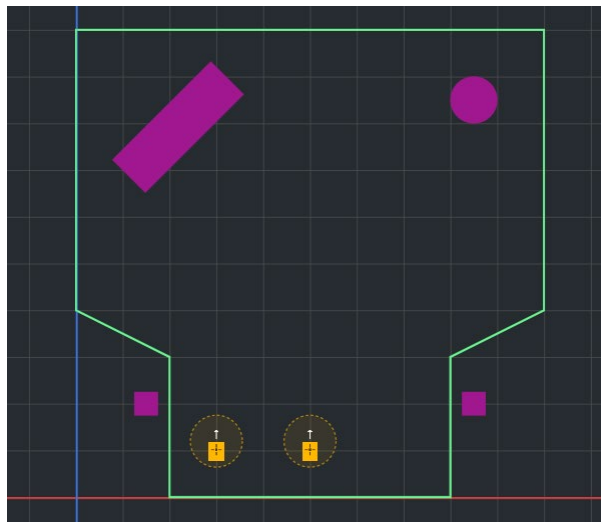
**Studio Limits for XY axis** – Studio limits define an area of operation for XY pedestals which no part of the pedestal may cross. Fixed obstacles can also be defined. The shape of the area of operation and of the obstacles can be a polygon of arbitrary shape, a rectangle, or a circle.

Studio limits are created in a separate tool, Studio Creator. A 'studiocfg' file is exported from Studio Creator and loaded onto a robot through the new Studio Tab in the Furio web interface.

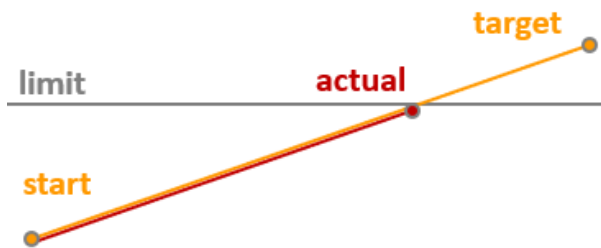
- **Ethernet Collision Avoidance** – Collision Avoidance data is now exchanged over the Ethernet network, rather than CAN bus. This removes the limitations of number of dollies and track length imposed by the CAN-based collision avoidance system.
- **Change to XY limit behaviour** – The following diagram illustrates the pedestal behavior in the case of a preset or move to a target position that is beyond a limit. The XY axis now stops at the first limit encountered. Joystick operation is unchanged; the XY axis also stops at the limit.

Previously, for presets and moves the XY trajectory was altered to follow the limit.
