# Tria+ UHD Production Server • Software Release Notes

Welcome to the Tria+ UHD V9.3.1 Software Release Notes. Please read this document to find important information on areas of Tria+ UHD that may not be covered in the Getting Started Guide or the User Help system.

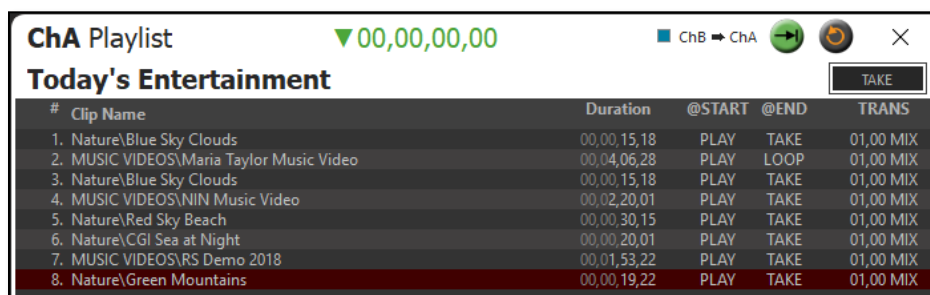
When the Playlist finished playing out all content, the Count-Down timer displays zero:

It should be noted that if the "PVW-PGM playout option" is selected (**blue** checkbox enabled at top of Playlist pane), then the Total Run Time of the playlist takes into account the TRANS durations of all the items in the Playlist, and will reduce the Count-Down timecode:

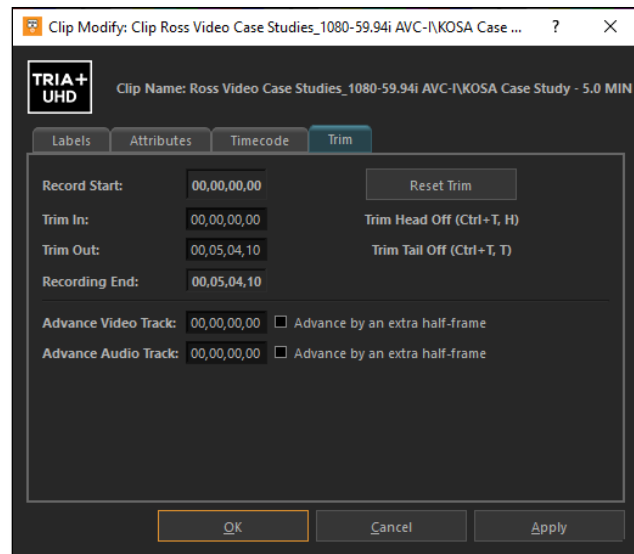
When using the "Clip Modify" dialog window with the "Trim" tab selected (*shown below*), the "Trim In" and "Trim Out" functions did not operate correctly, while the associated QWERTY keyboard shortcuts did operate correctly. These bugs are now fixed.
